**Photos of Existing Conditions**

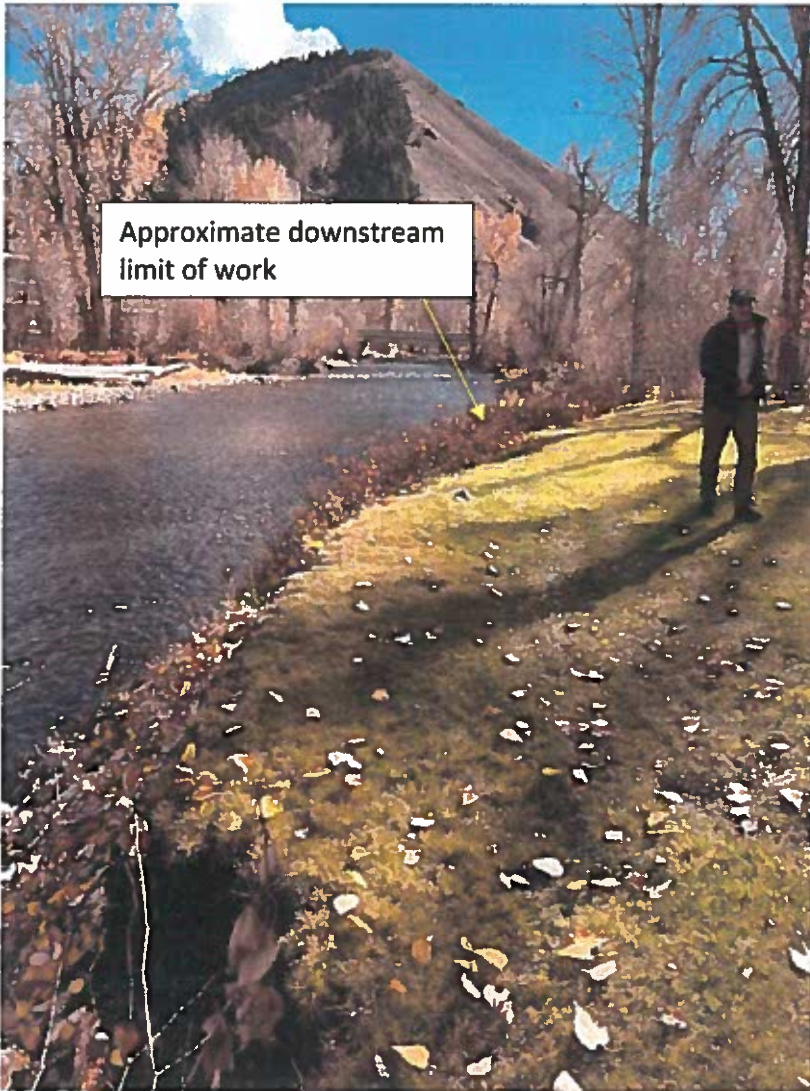
Looking downstream from near undercut tree

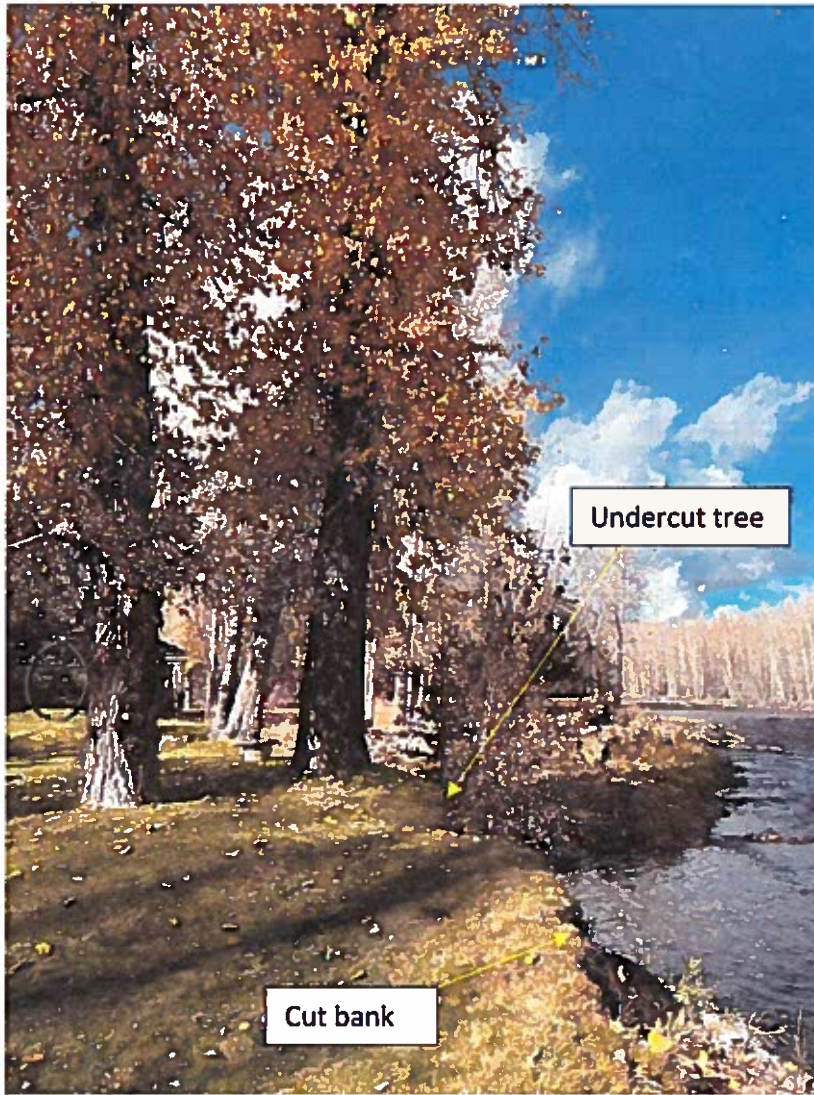
Looking upstream at cut bank and undercut cottonwood tree

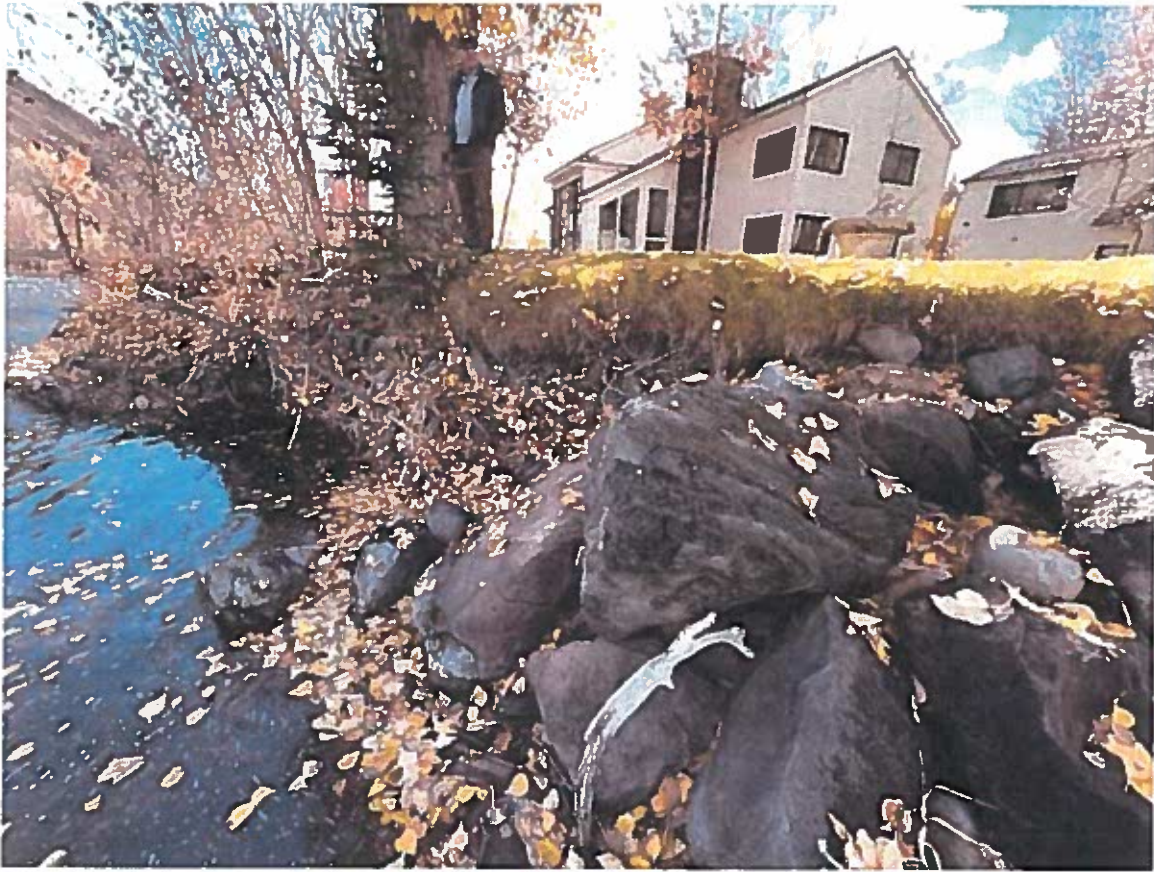
Looking upstream at severe bank undercut at tree. Upstream end of legacy riprap visible in foreground.

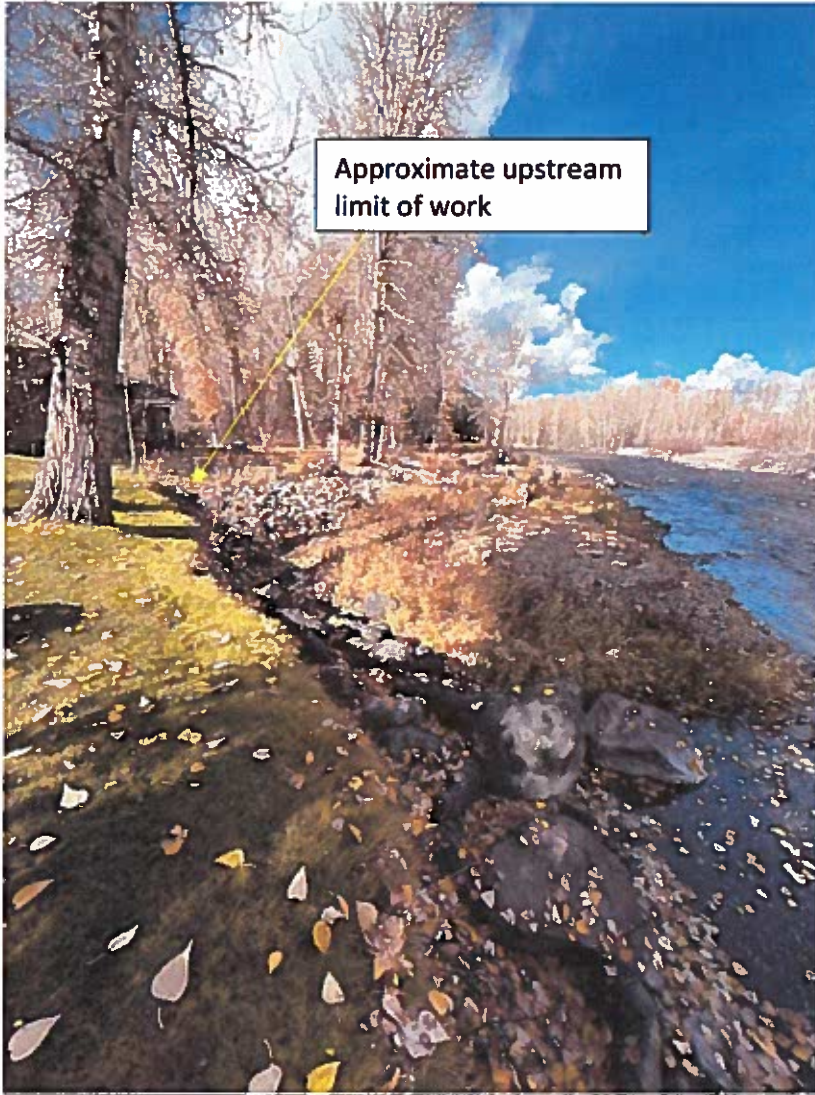
Legacy riprap to be vegetated.

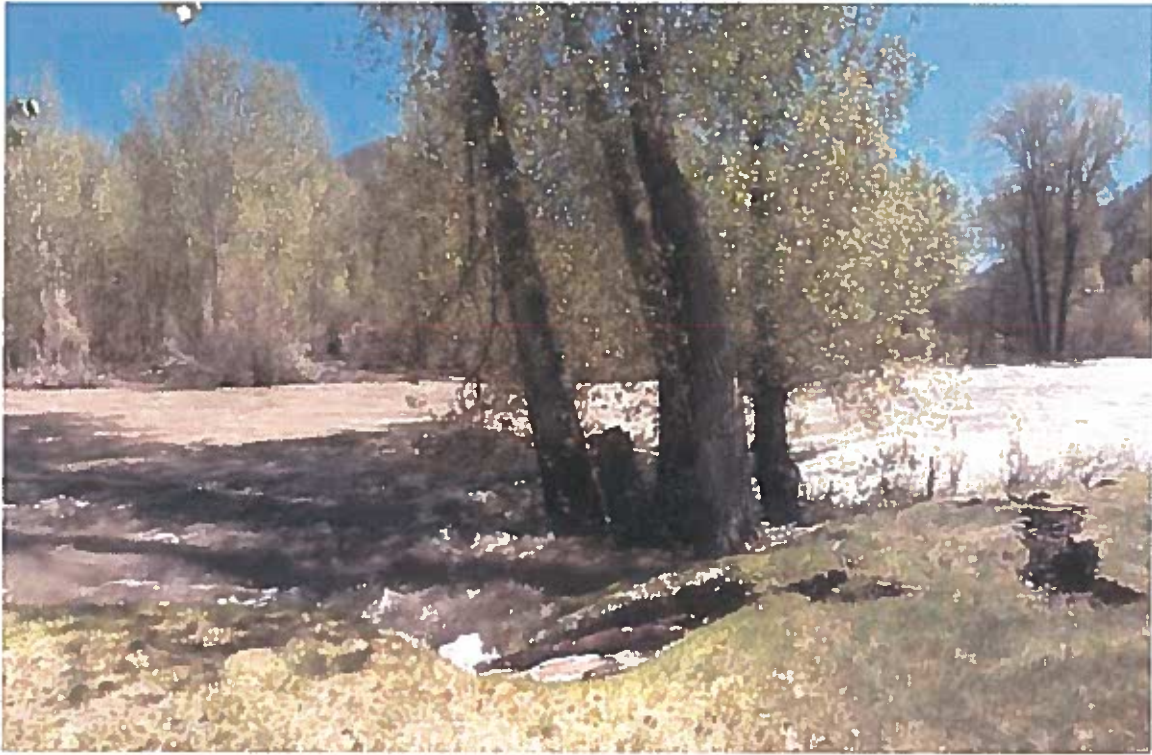
**Flood conditions on May 10, 2017. Flow is left to right, bank erosion and development of scour hole at cottonwood tree is evident.**
